APPLICATION OF ADVANCED COATING TECHNIQUES TO ROCKET ENGINE COMPONENTS

S. K. Verma^{*}

ABSTRACT

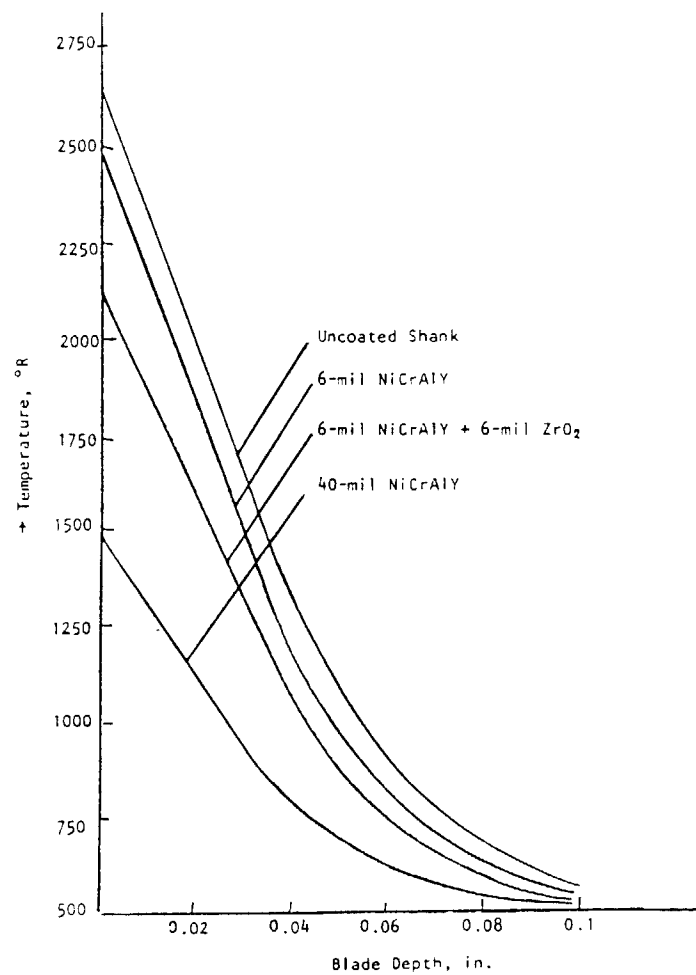
If the bond strength of the coating is only 900 psi, then 10 mils of coating can be tolerated. However, depending on the bond strength, the thickness of the coating would vary as shown in Figure 2.³ The temperature distribution in the shank area has been found to be critical as melting and cracking have been observed. Figure 3³ indicates that a considerably thick coating would be necessary to reduce surface temperature to 1500°F (815°C) levels. This means that two types of coatings of different thickness, for the airfoil and for the shank area, would be required.

Figure 3. Temperature distribution in shank trailing edge. (Source: NASA-Marshall.³)

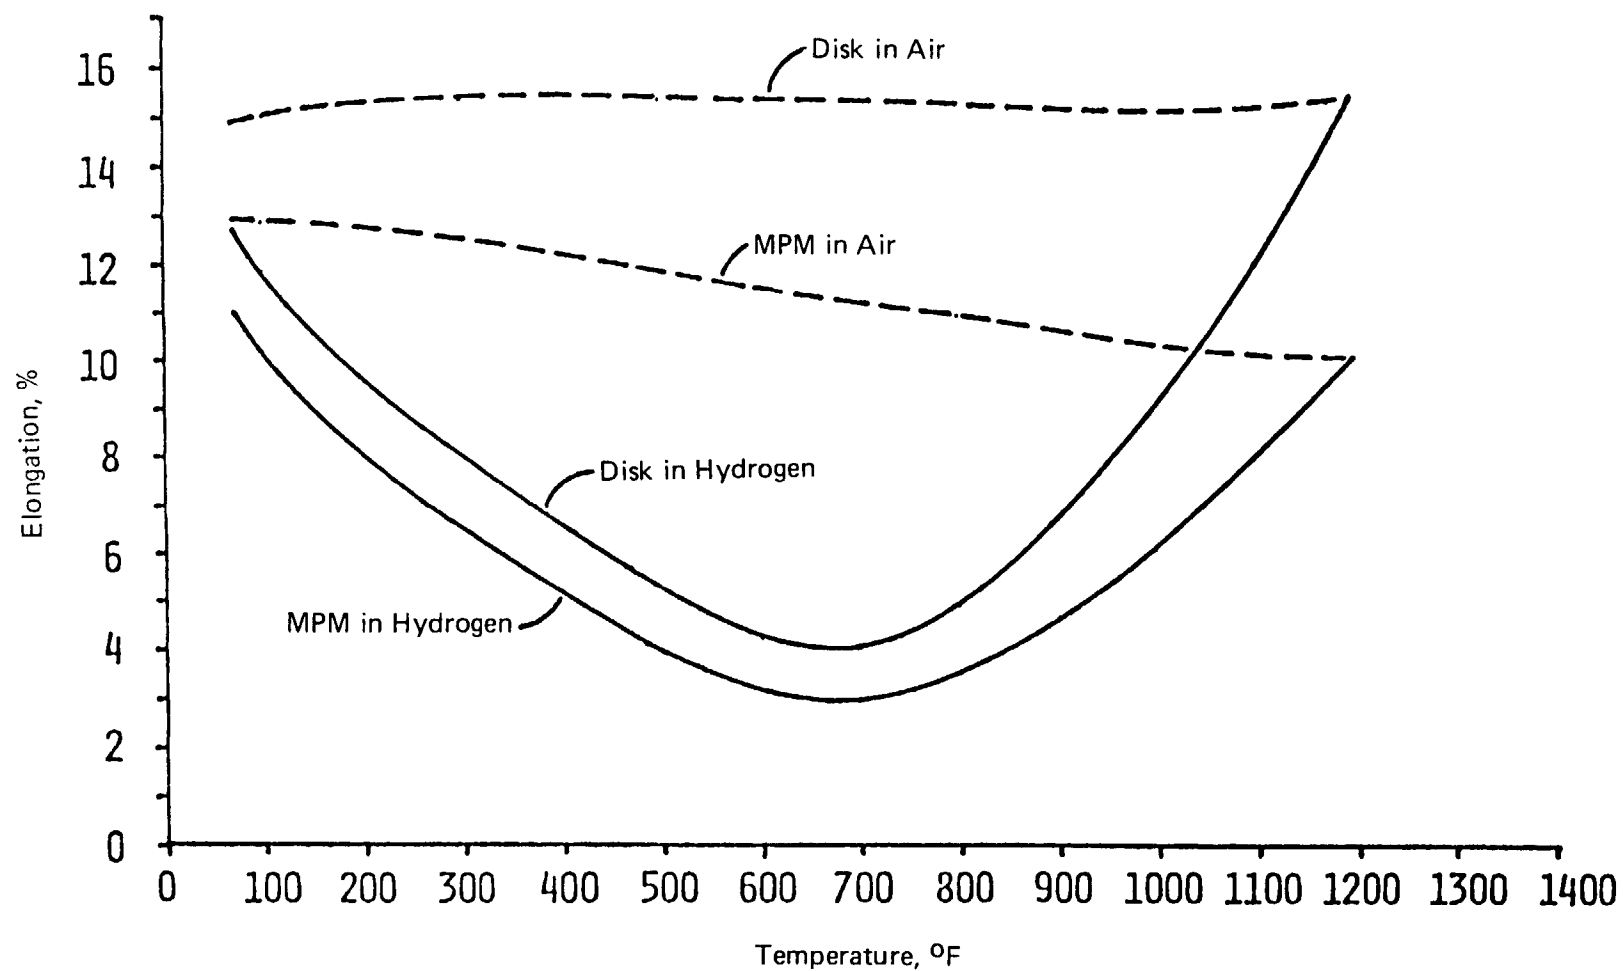
The problem was quite severe since the properties of Waspaloy TMP in hydrogen are adversely affected as shown in Figure 10. The elongation and low cycle fatigue data clearly show the importance of gold coating. This affects the allowable speed of the disk as shown in Figure 11.

Figure 10. Ductility (measured as elongation of Waspaloy as a function of temperature in air and in hydrogen. (Source: Rocketdyne.³)

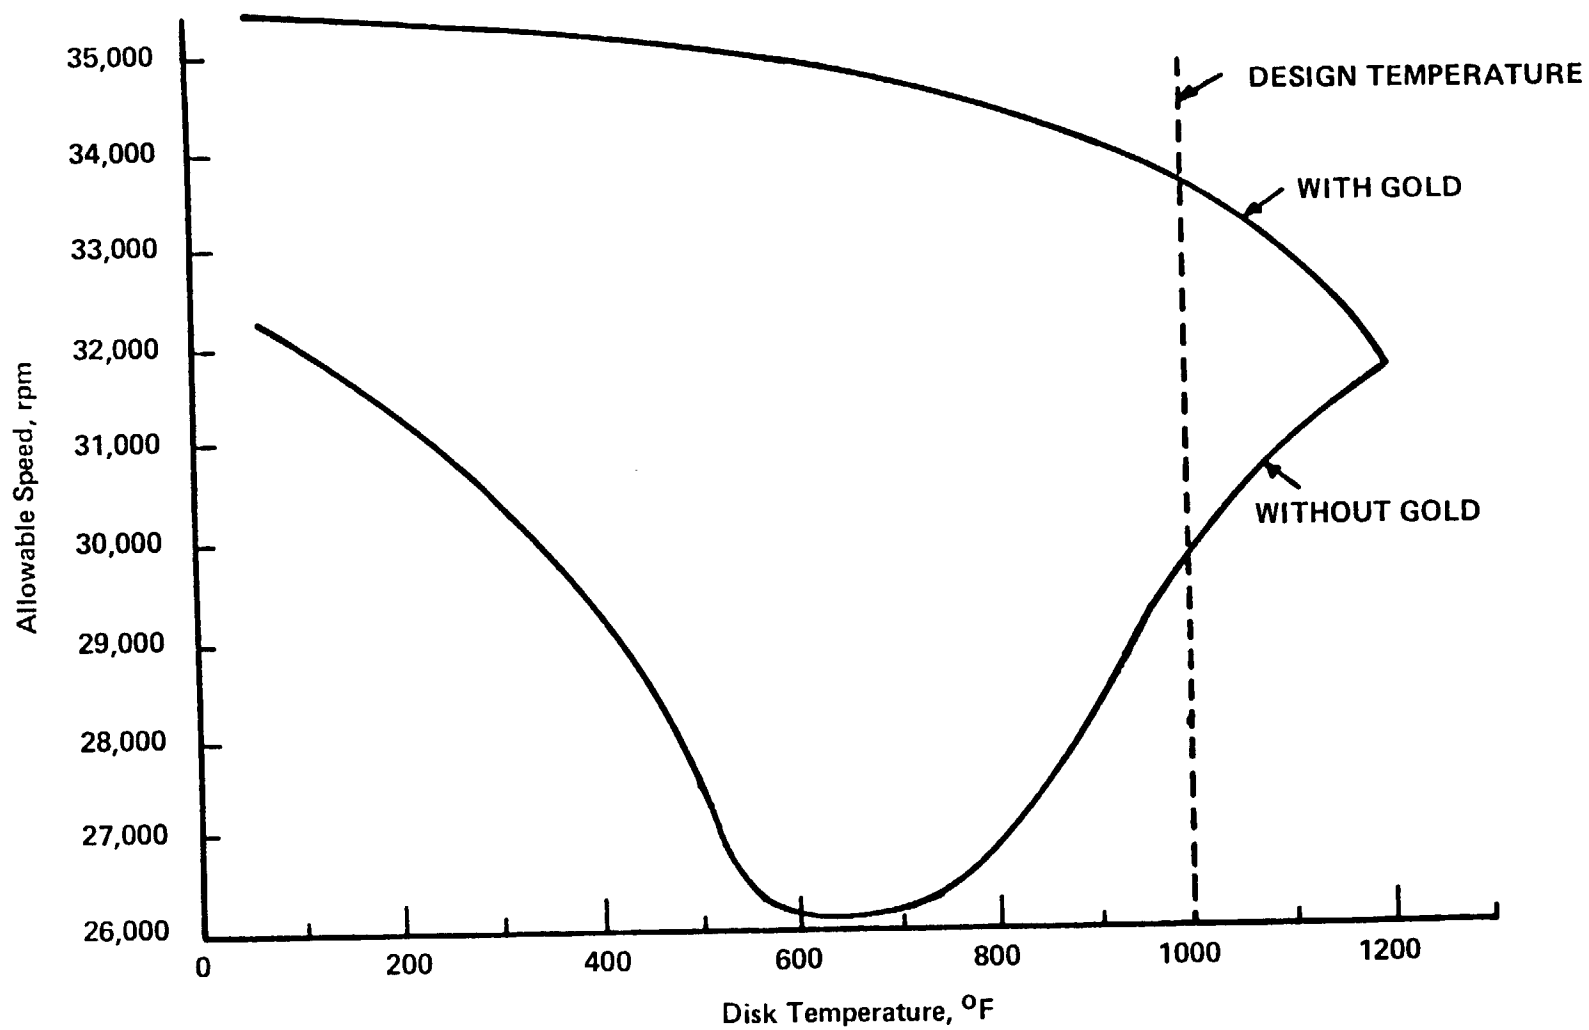
Figure 11. Allowable speed with or without gold for the first-stage disk at various disk temperatures. (Source: NASA-Marshall.³)

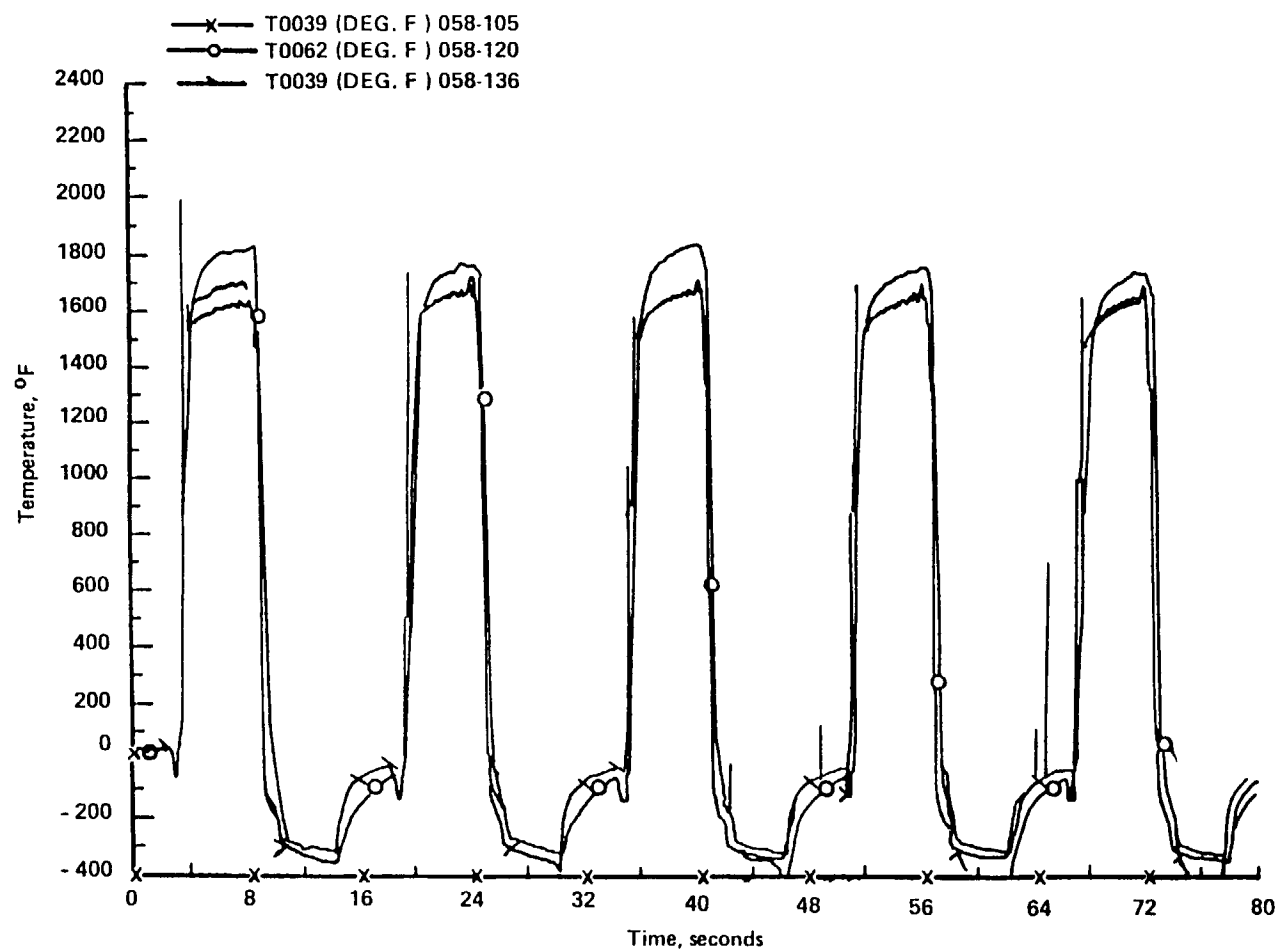
In these tests, the thermal cycle was characteristically a nominal maximum chamber temperature of approximately 1700°F (927°C) and a nominal maximum chamber pressure of approximately 2500 psi, down to a nominal minimum chamber temperature of -350°F (-212°C) and a nominal minimum chamber pressure of 160 psi. Figure 12 is a plot of a high, a nominal, and a low chamber temperature seen during the course of the testing. For simplicity, two of the schematics prepared by NASA-Marshall are shown in Figure 13 illustrating the type of cracking. In fact, all the coatings of various compositions applied by conventional methods had cracks of the type shown in Figure 13.⁵

Figure 12. Variations in chamber temperature in NASA-Marshall's thermal fatigue rig.⁵
